INSPECTION CONDITIONS

INSPECTION SITE: Your New Address.

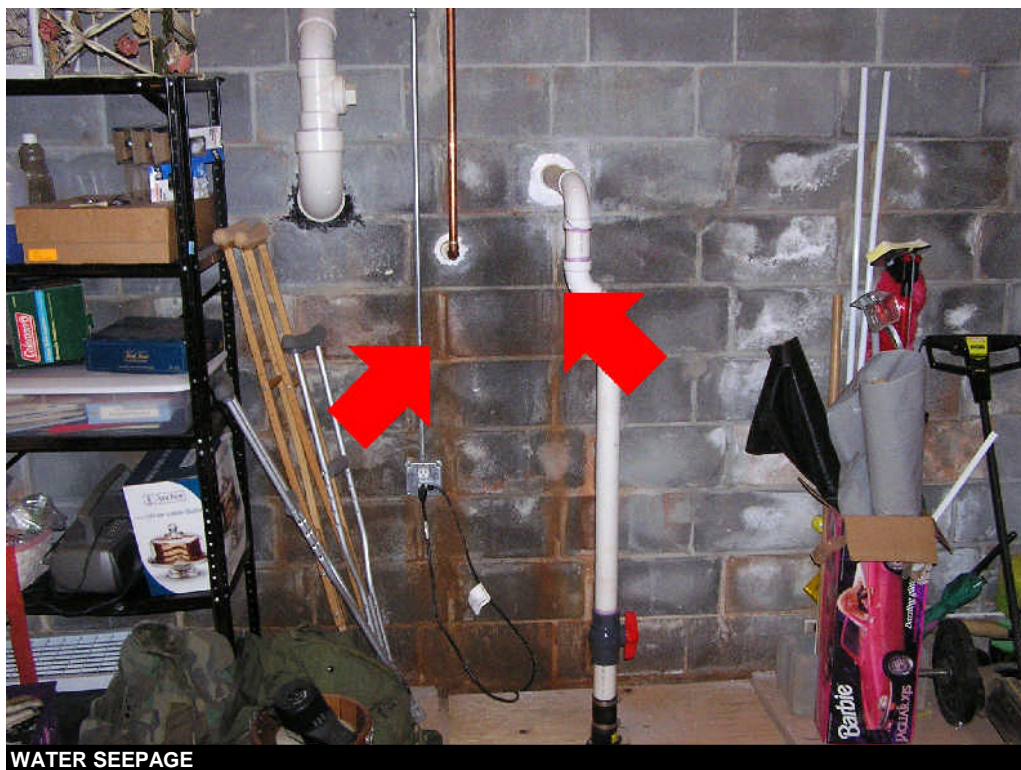
CONDITION: **Substantial foundation water seepage was observed. Since repairs are needed to protect the building from more serious damage, a structural engineer who is familiar with foundation repair or a company specializing in foundation repairs should be consulted to evaluate the condition and suggest corrective measures.**

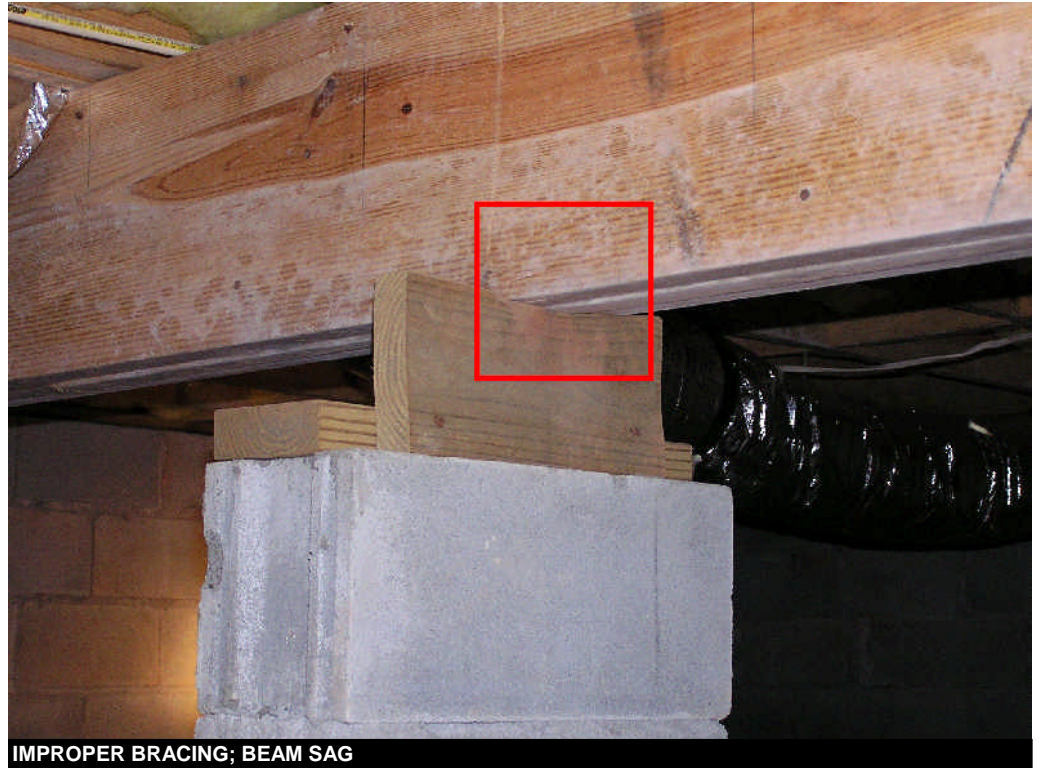
CRAWL SPACE: **Broken/sagging framing.**

CONDITION: Symptoms of prior water seepage are present.

BEAMS: **Beam sagging and/or cracked.**

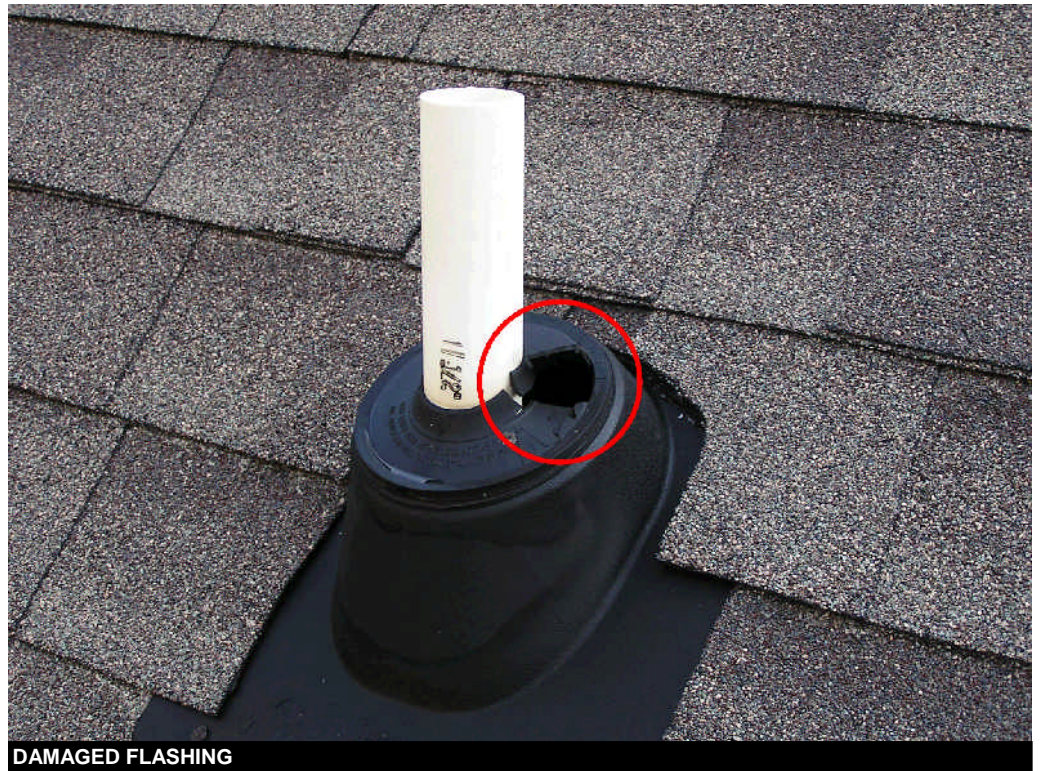
TYPE AND CONDITION: Metal, Rubber, **Damage is noted- at the vents.**

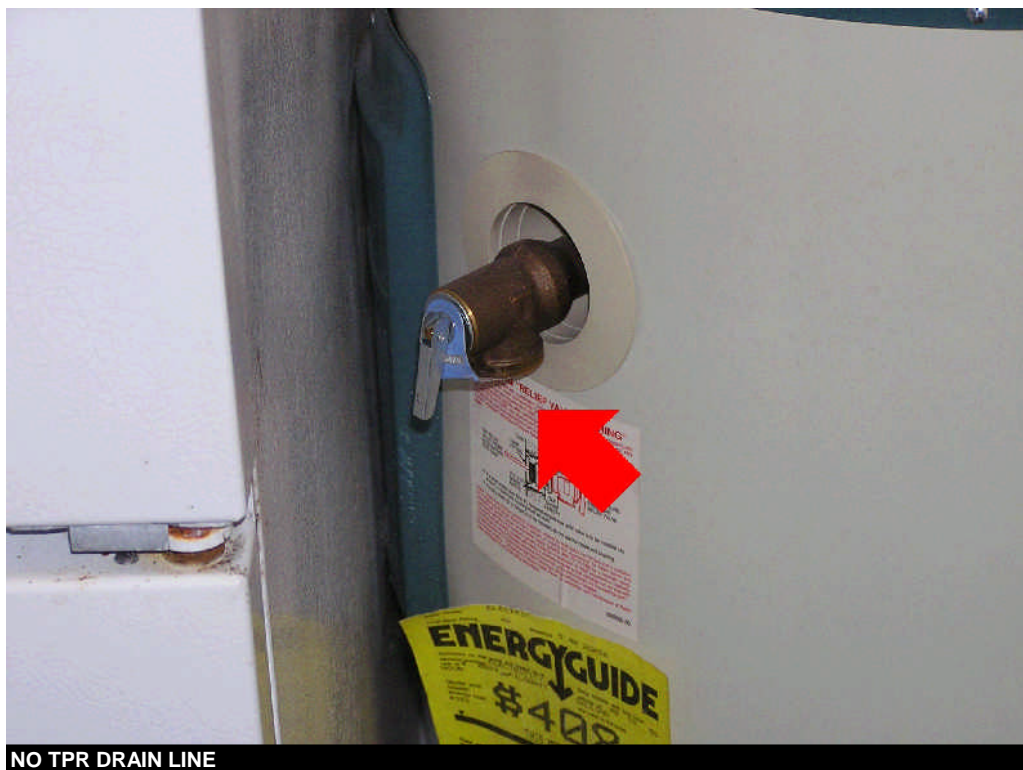
CONDITION: Appears serviceable, **Pressure relief valve drain line is missing or ends prematurely. This is a SAFETY HAZARD. We recommend this drain line be extended to a safe location.**

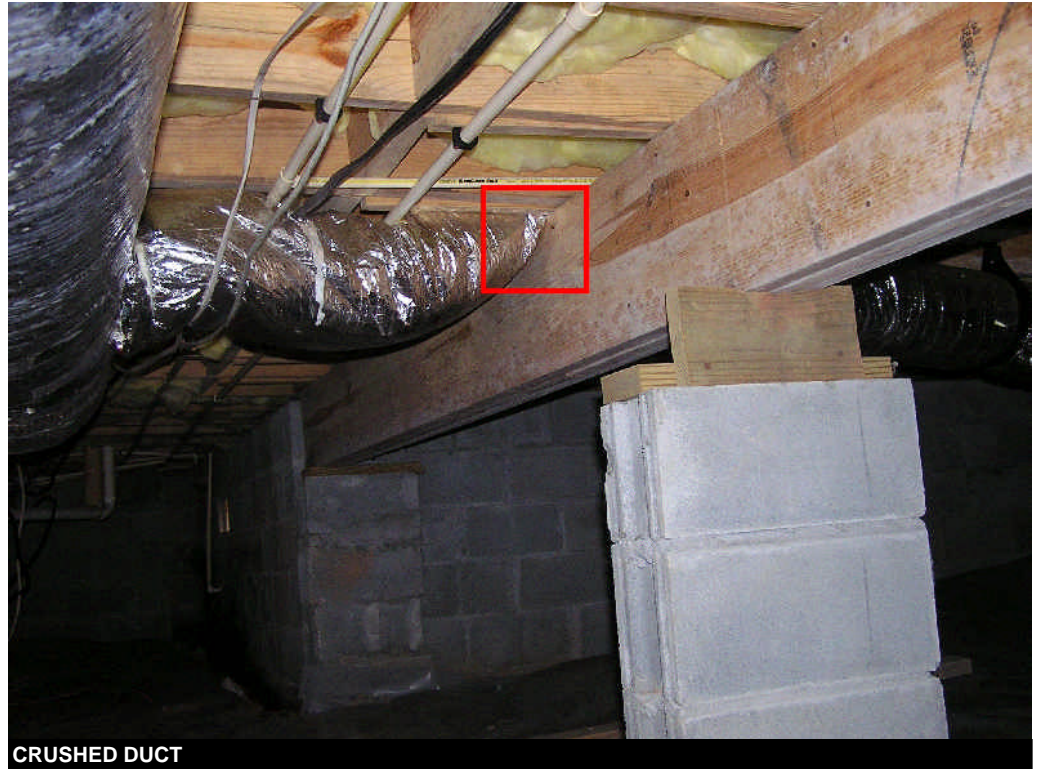
CRUSHED DUCT

DUCTS/AIR SUPPLY: **Crushed ducts noted.**

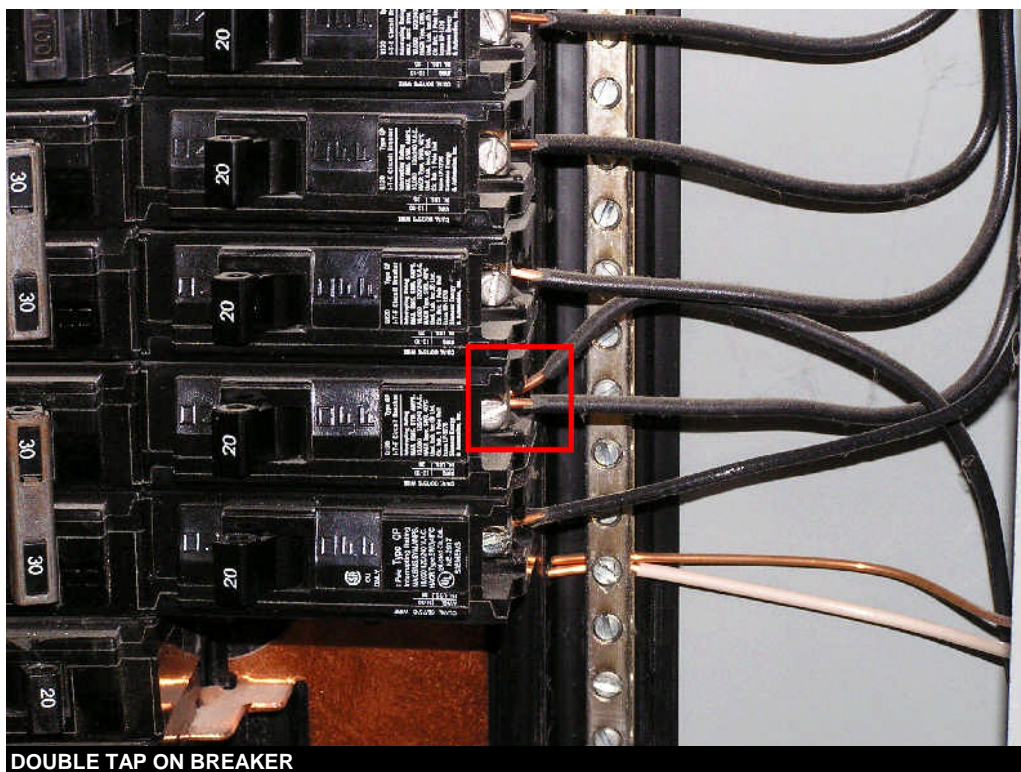
Inspector Notes: Circuit and wire sizing correct so far as visible, Grounding system is present, **Multiple wires are connected to a single lug on a circuit breaker where only one wire should be connected.**
